MARINE INVESTIGATION REPORT

M00C0019

GROUNDING

CHEMICAL TANKER *SUNNY BLOSSOM*

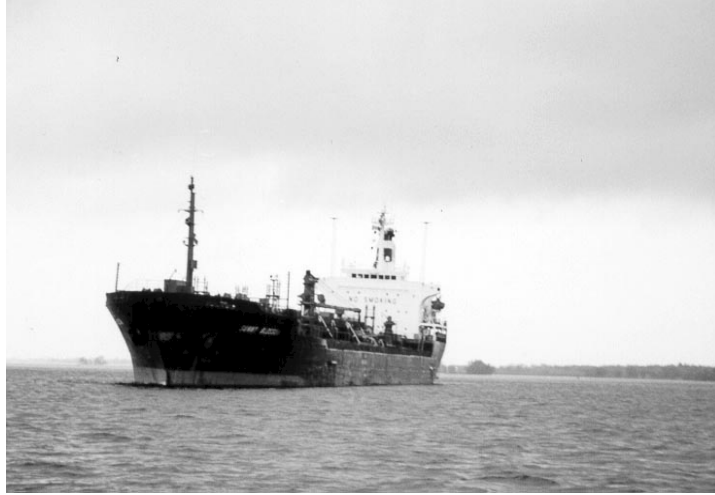
The apprentice pilot observed that the heading markers of both radars were approaching 280° G and advised the pilot accordingly. The pilot went to the radar, commented on the poor radar performance and immediately ordered the OOW to reduce speed from about 7 kn to the dead slow ahead speed of 5 kn. The vessel continued to swing to starboard across the channel. There is conflicting information as to what helm orders were given. One account maintains that there was no time to give helm orders, whereas another account maintains that a series of port helm orders was given. At 0730, the chemical tanker grounded upstream of buoy D36, on the north side of the channel, on a heading of 274° G. The vessel was aground starboard side to the shoal with a list to port of 2.5° (see Appendix A, Photo 1).

Photo 1. *Sunny Blossom* aground in Lac Saint-François with a list to port of 2.5°

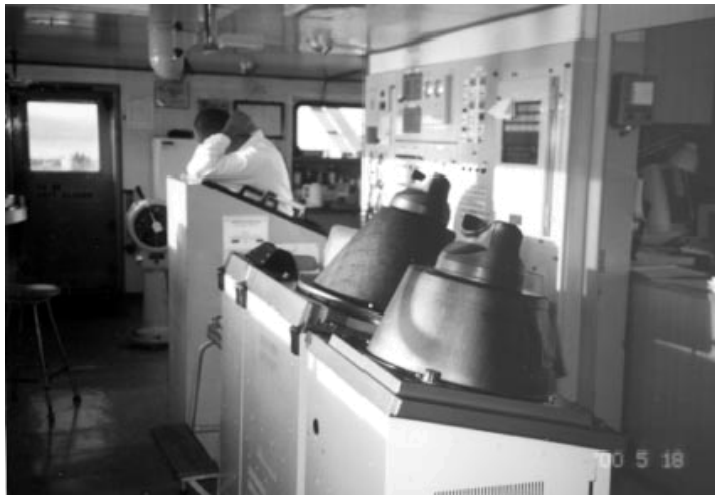
The vessel was fitted with an electronic chart system (ECS). It had been installed on the chart table console, abaft the steering station, the vessel having a traditional bridge layout with chart table in the after part of the wheelhouse (see Appendix A, Photo 2).

The ECS installed on the *Sunny Blossom* was not calibrated with the on-board global positioning system (GPS) and was, therefore, not available for safe navigation. Both the crew and pilot were aware of this, and it was not used during the course of the voyage.

Photo 2. View from port side of wheelhouse looking to starboard, showing navigation equipment and chart room partition bulkhead behind which the ECS is located

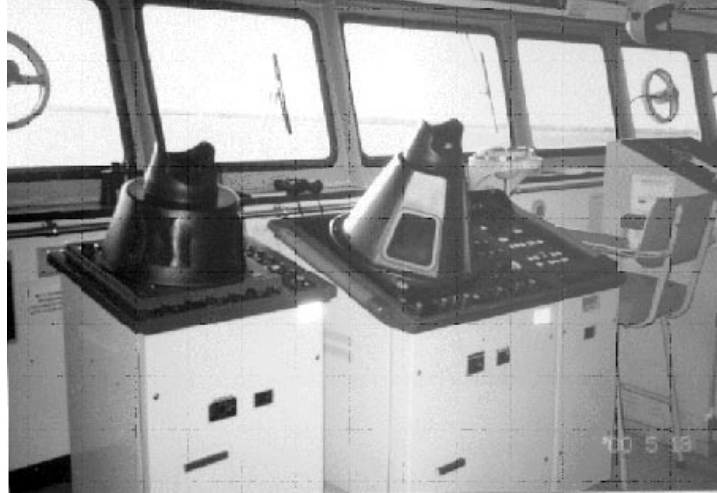
The *Sunny Blossom* was not equipped with a modern type of bridge layout. Those who controlled the vessel’s movement had to look above the central forward window to see the helm indicator, look toward the starboard side of the bridge to confirm the engine telegraph setting, walk to the port side of the bridge to monitor the radars, and walk to the chart table abaft the central control panel to read the chart or monitor other navigation equipment.

Photo 3. View from port side of wheelhouse looking forward

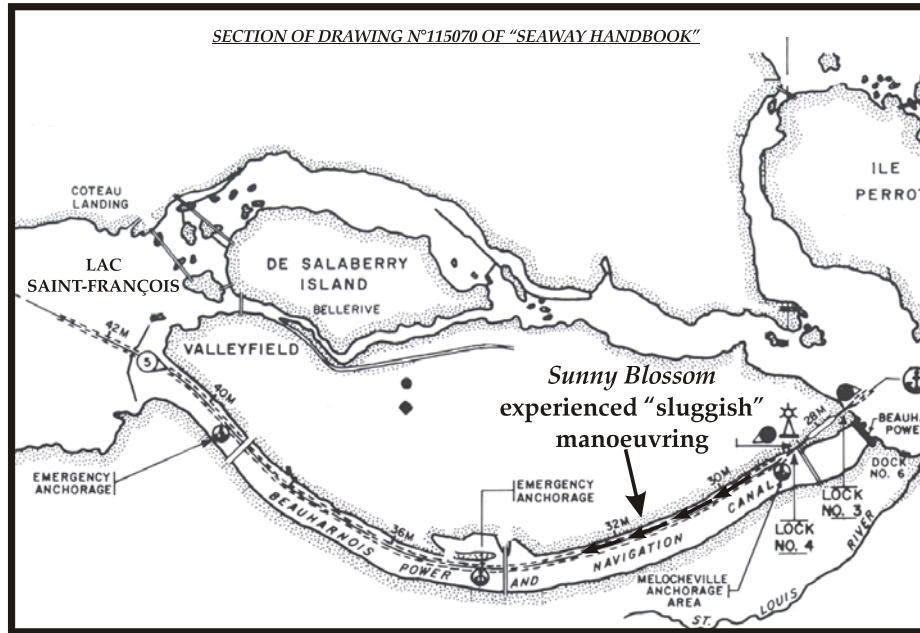
The apprentice pilot commented on the sluggishness of the vessel when leaving the shallow channel exit from the Beauharnois Lock No. 4 at a speed of only 6 to 7 kn. However, this is not an unusual phenomenon for a ship moving in a narrow channel such as the Beauharnois Canal, which has a depth of only 8.2 m (see Appendix B, Sketch 1). This phenomenon would also exist for a ship navigating in the Lancaster Channel, where the depth of the water is only 0.5 m more than in the Beauharnois Canal.

Sketch 1. Area within the Beauharnois Canal where the *Sunny Blossom* experienced "sluggish" manoeuvring

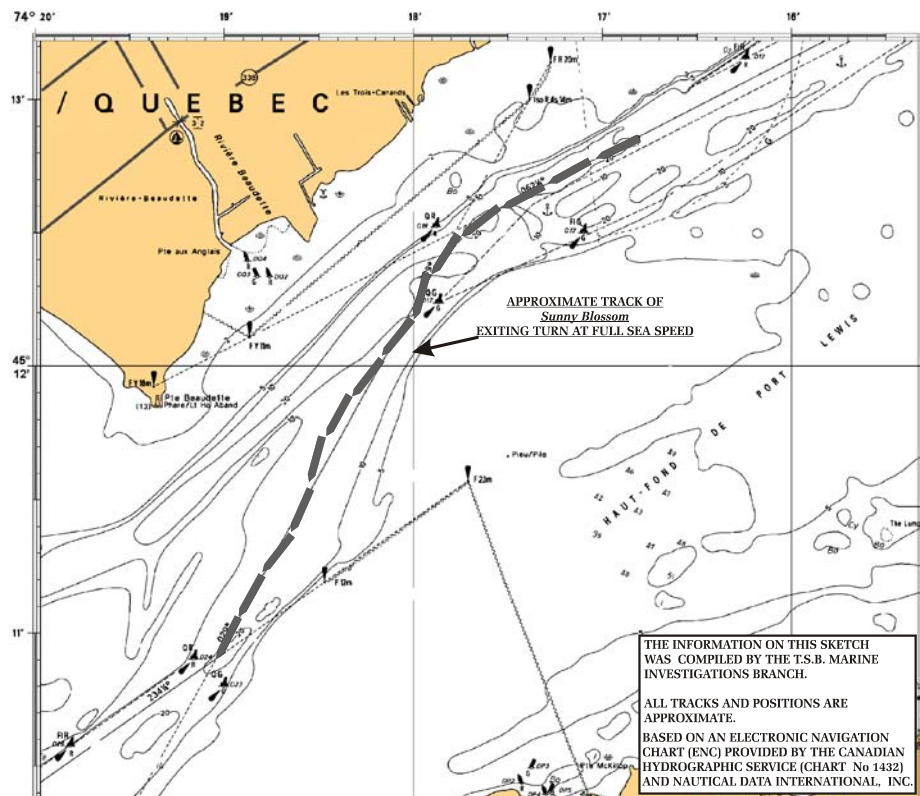
Sketch 2. Section of Canadian Hydrographic Service Chart No. 1432, showing the approximate path of the *Sunny Blossom* when exiting the steady turn at full ahead sea speed
